## **Crank Sensor Signal Investigation on Ashok-Leyland 6 liter CNG Engine using the OH4.0 Platform**

J.W. Macqueene

July 9, 2008

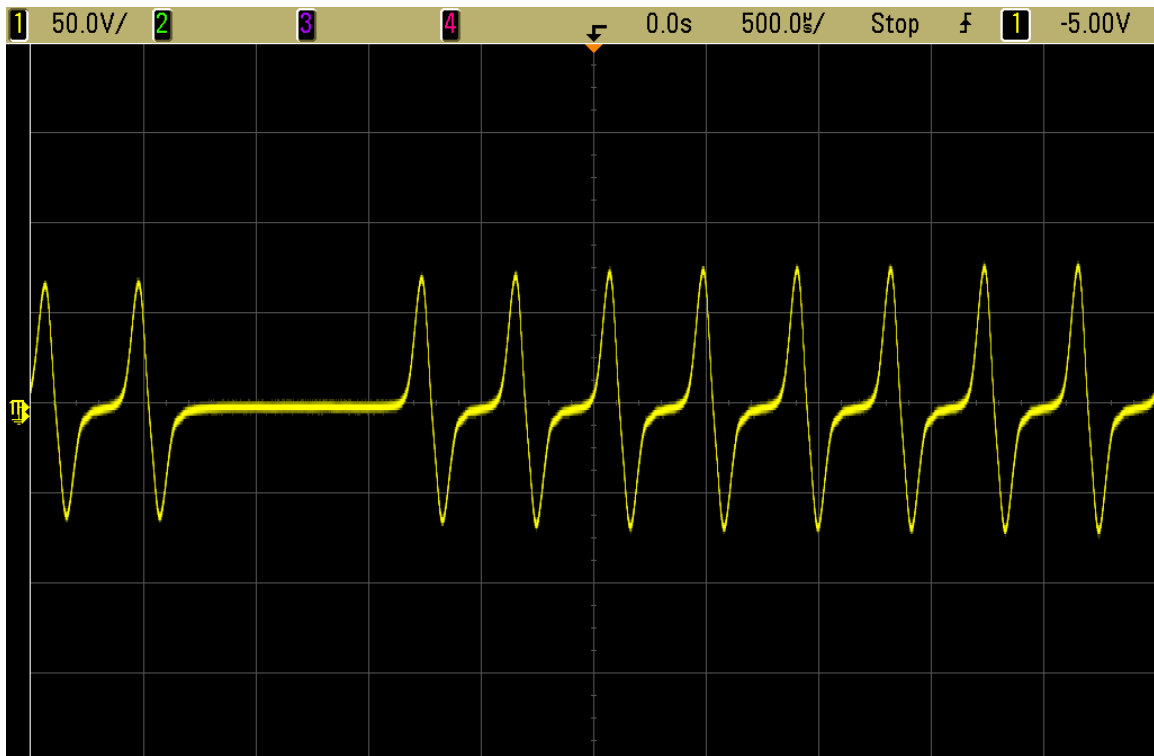
When the engine is operated at low engine speeds, the sensor produces a relatively uniform signal such as the one shown in figure 2:

Figure 2: Normal Crank signal waveform – missing tooth gap shown.

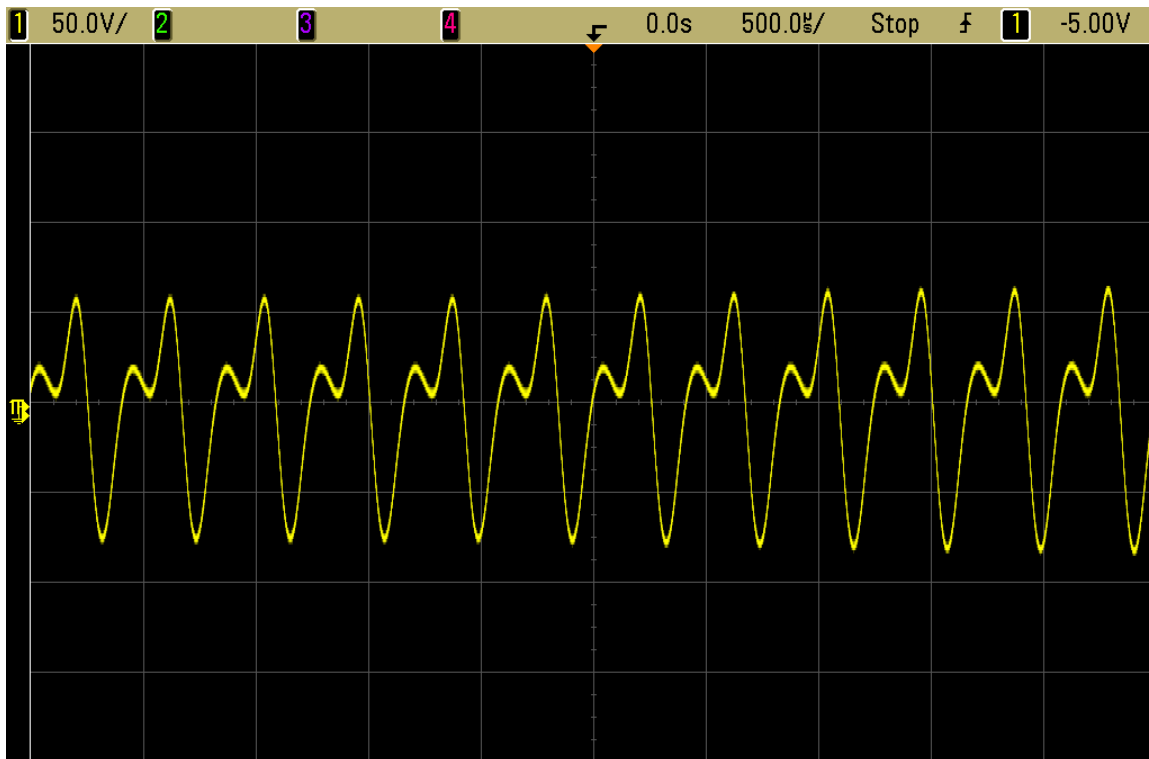
At higher engine speeds (e.g. 2400 rpm) the waveform develops a hump on the rising edge as shown in figure 3. The hump occurs above ground voltage. This waveform irregularity has been shown to induce encoder faults on the SECM-48.

Figure 3: Waveform at 2400 rpm

1. The root cause of the waveform irregularity is input circuit capacitance contributing to ringing in the R-L-C.
2. Solutions which have been presented to Ashok-Leyland are as follows:
  - a) Include 10K ohm resistor in the wiring harness between the sensor and the SECM-48. In general, this is not a desirable thing for wiring harness design, but is an expedient solution.
  - b) Modify input circuit in SECM-48. This approach would be costly and may adversely impact release of the system to Ashok-Leyland. EMC compliance would need to be re-confirmed. Unless the changes were validated on all current SECM-48 applications, this would necessitate a custom part for Ashok-Leyland.
  - c) Select an alternative crank sensor which is compatible with the SECM-48 input circuitry.

Ashok-Leyland has agreed to add a 10K ohm resistor in the wiring harness.

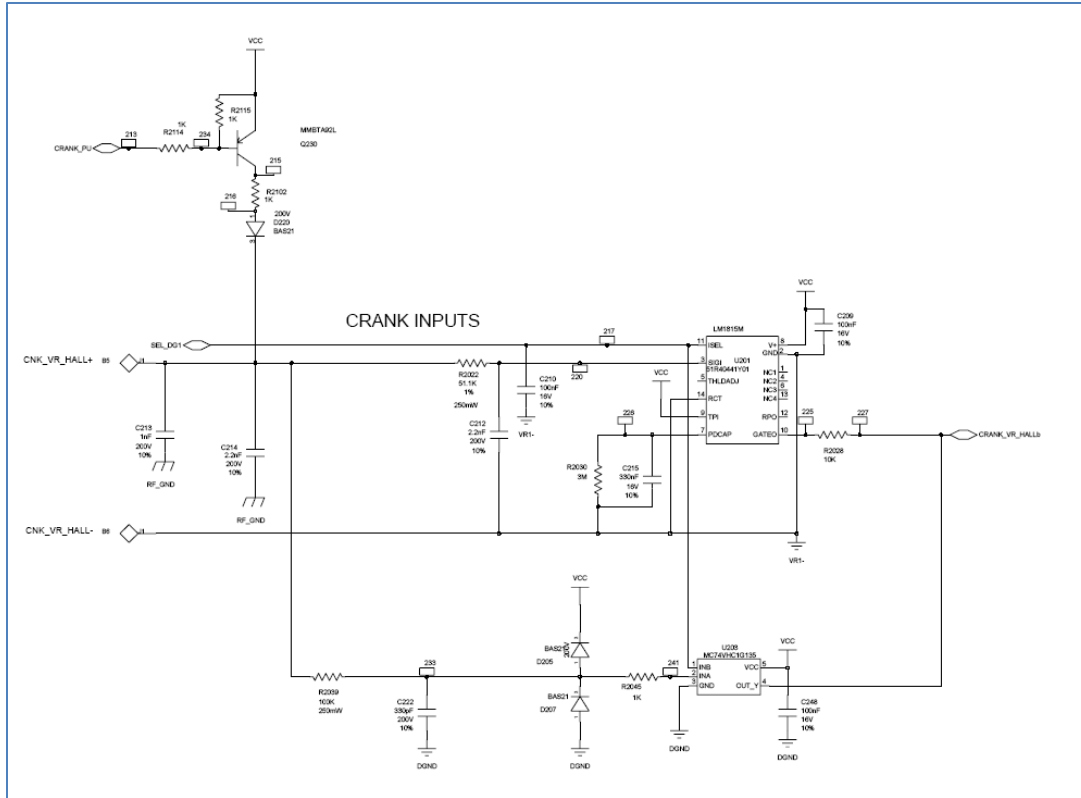
The SECM-48 employs the crank sensor interface circuit shown in Figure 4. This is a dual purpose interface, suitable for use with either variable reluctance or Hall-Effect sensors. The LM-1815 circuit provides the variable reluctance interface while the MC74HC1G135 circuit provides the Hall-Effect interface. The Q230 transistor circuit provides a pullup for use with open-collector Hall-Effect sensors – this circuit is turned off when used with variable reluctance sensors. This circuit is similar, but not identical, to the crank sensor interface circuit used in the PCM-128 – refer to Figure 5.

Figure 4: Crank Sensor Interface in SECM-48

C213: This 1 nF capacitor to RF\_GND is provided for R-F decoupling. Removing this capacitor was shown to change the shape of the waveform slightly – moving the hump closer to ground.

C214: This 2.2 nF capacitor to RF\_GND is provided for R-F decoupling. Removing this capacitor was shown to eliminate the waveform irregularity.

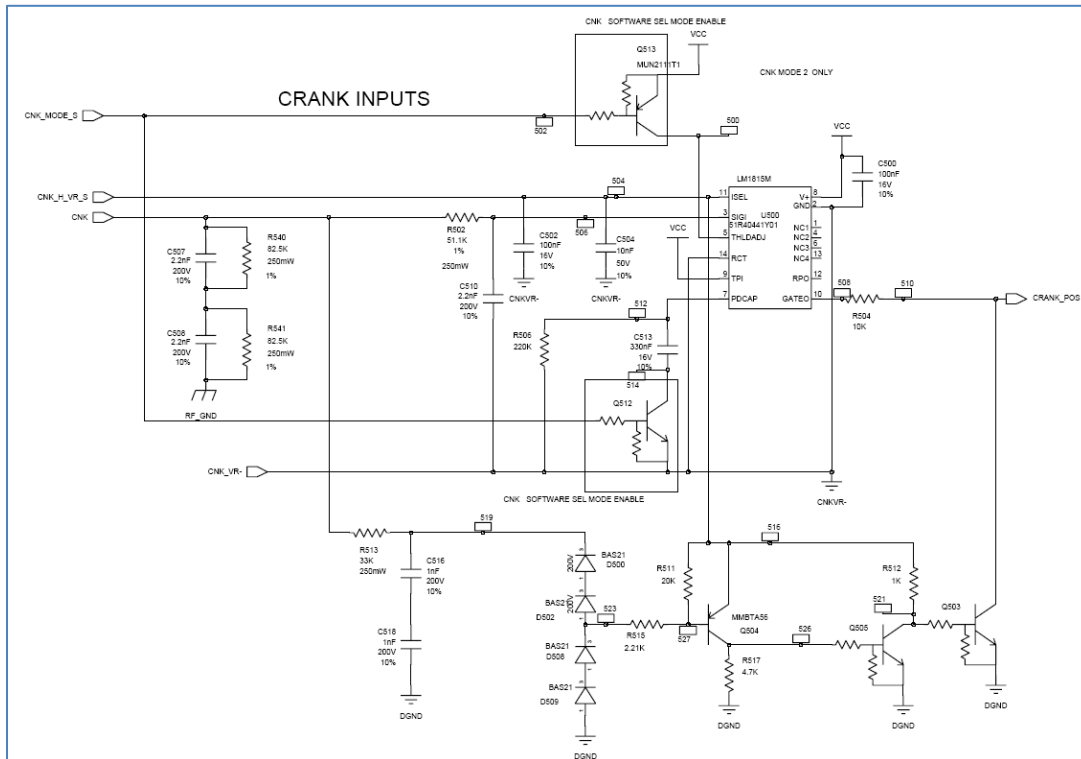
Figure 5: Crank Sensor Interface in PCM-128

Test PCM-128 for similar behavior: The flywheel housing was modified to accept a second Bosch crank sensor in order to permit evaluation of the sensor interface without disrupting engine control with the main SECM-48. A PCM-128 was wired to the second Bosch sensor. The PCM-128 did NOT display the signal irregularity. The PCM-128 has different circuitry for the Hall-Effect sensor, no pull-up circuitry, and slightly different RF decoupling.

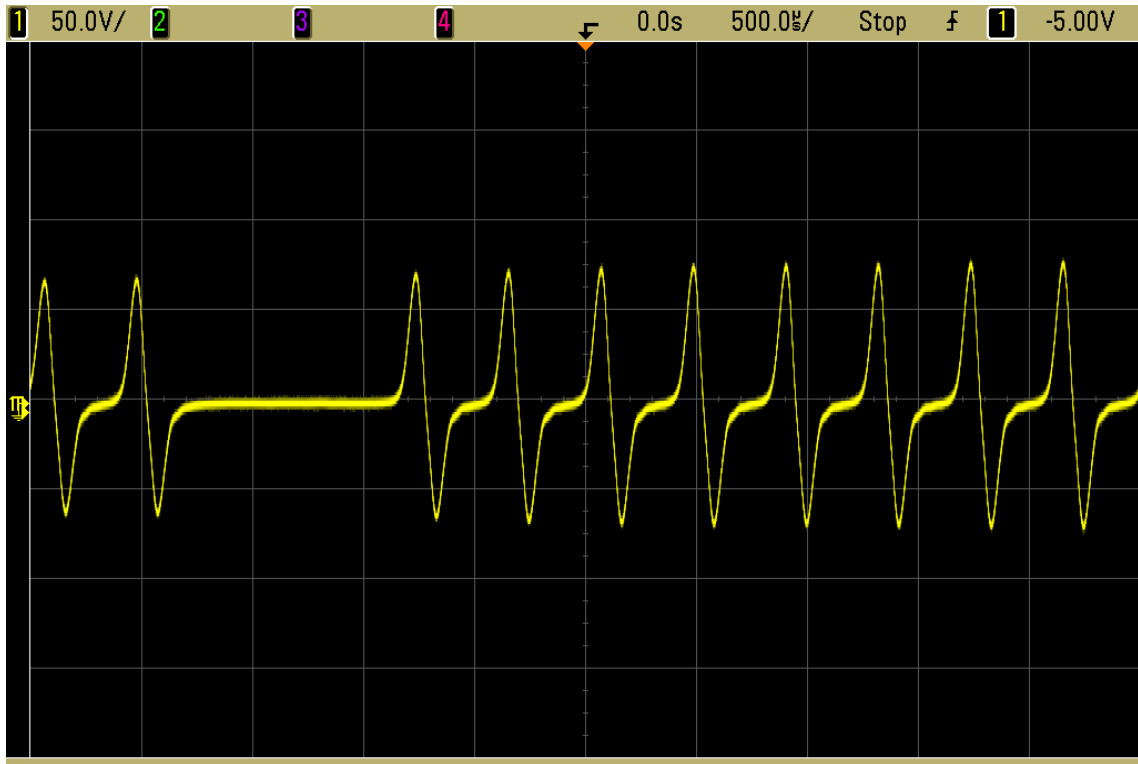
Open circuit: Open circuit waveform is shown in Figure 6 (same as Figure 2). No waveform irregularity was present.

Figure 6: Open Circuit Bosch Crank Sensor.

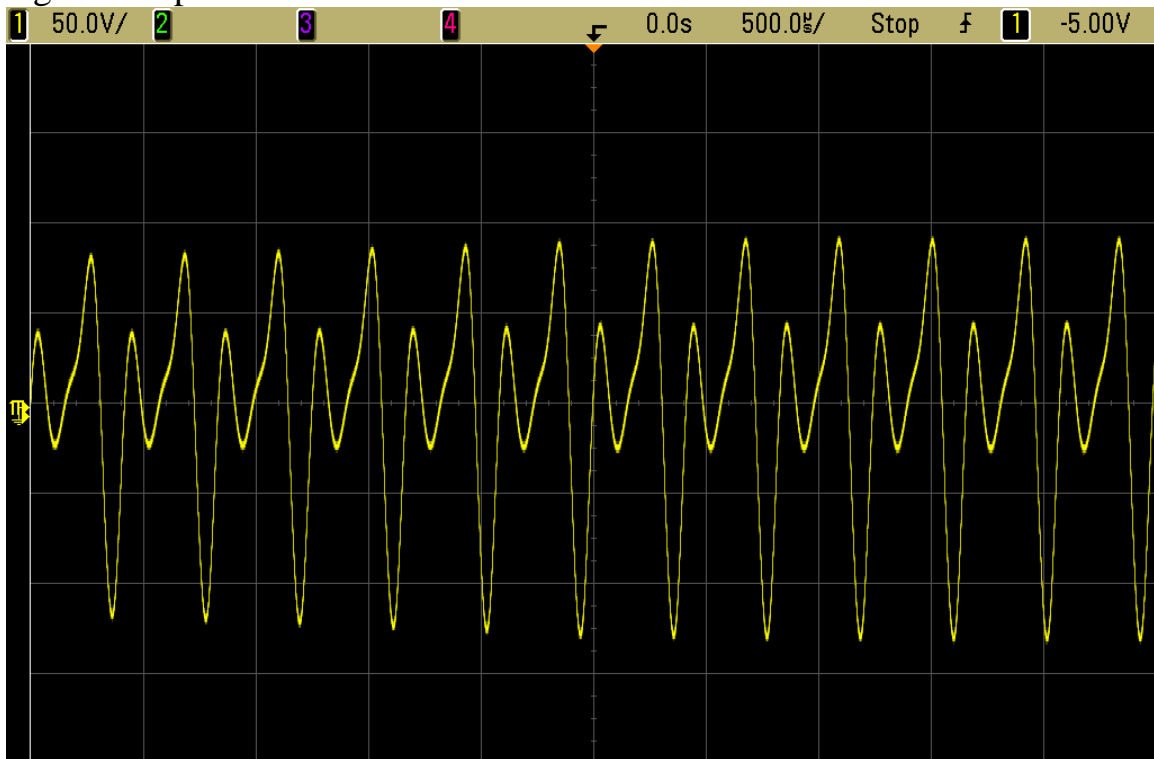
1nF: A 1nF external capacitor was placed across the sensor, resulting in the waveform shown in Figure 7. The irregularity was present.

Figure 7: Open circuit Bosch crank sensor with 1 nF capacitor.

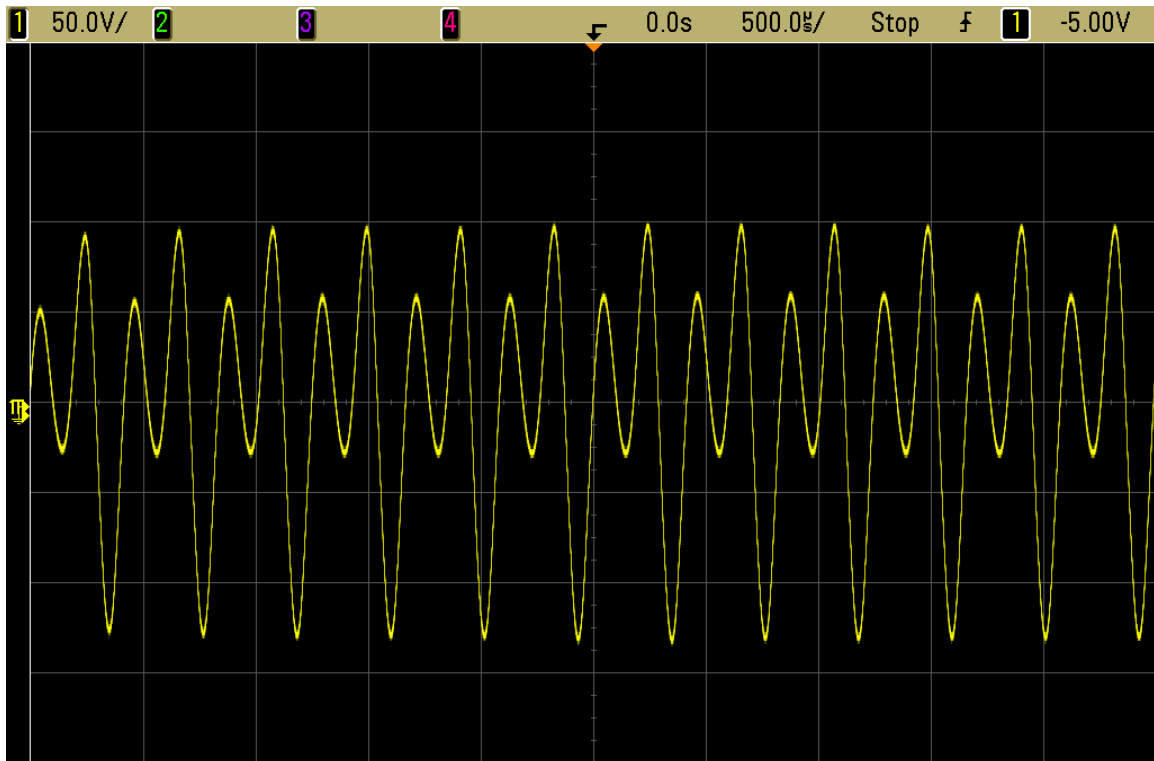
2.2nF: A 2.2nF external capacitor was placed across the sensor, resulting in the waveform shown in Figure 8. The irregularity was present with greater amplitude than seen with the 1nF capacitor.

Figure 8: Open circuit Bosch crank sensor with 2.2 nF capacitor.

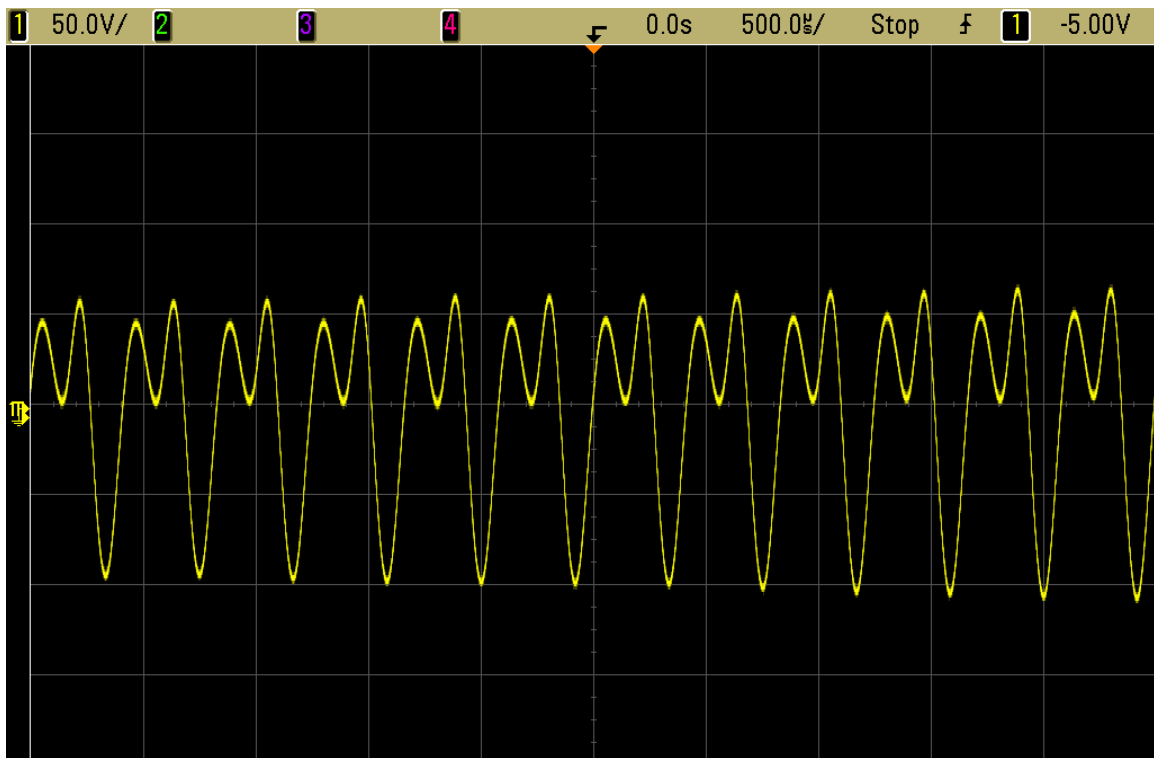
1nF+ 2.2nF: 1nF and 2.2nF external capacitors were placed across the sensor, resulting in the waveform shown in Figure 9. The irregularity was present. Overall signal amplitude was reduced from the waveform seen with the single 2nF capacitor.

Figure 9: Open circuit Bosch crank sensor with 1nF + 2.2nF capacitors.
