Application Note 51342 (Revision A, 11/2008)
Original Instructions

## **GS6 Flushing Procedure**

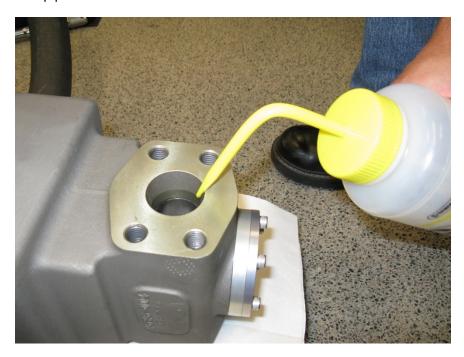
3. While the valve is stroking, an isopropyl alcohol or similar cleaning agent should be used as shown. Use a cotton swab to scrub the valve internals.

This cleaning should be performed for a few minutes, letting the alcohol wash away the lubrication.

There is a possibility that lubrication can be carried from below the 0% control point back onto the element and shoe. Because of this possibility, the valve should be power-cycled a minimum of 10 times in between the ramp procedure to ensure that all of the lubrication is cleaned off.

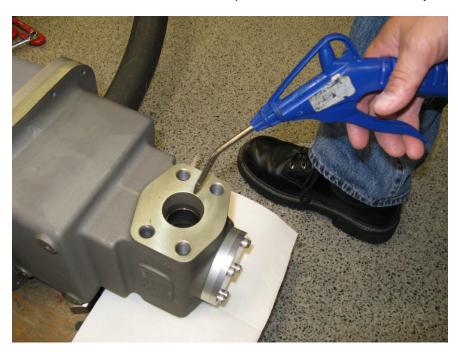
4. After the metering element and shoe are thoroughly cleaned, the area should be dried using low-pressure nitrogen or compressed air. Take care not to introduce impurities or oil.

To verify that the port has been entirely cleaned, the valve should be power-cycled and monitored at the 0% valve position point. If the valve starts up OK after a minimum of 10 times, the port has been cleaned effectively.
